SANTA PAULA PEAK, CALIF.
NE/4 SANTA PAULA 15' QUADRANGLE
N3422.5-W1900/7.5

SHEET 2 OF 4

RECONNAISSANCE SURFICIAL GEOLOGIC MAPS OF THE SANTA PAULA, SANTA PAULA PEAK, SATICOY, AND OJAI 7.5' QUADRANGLES, VENTURA COUNTY, CALIFORNIA

by Douglas M. Morton 1976

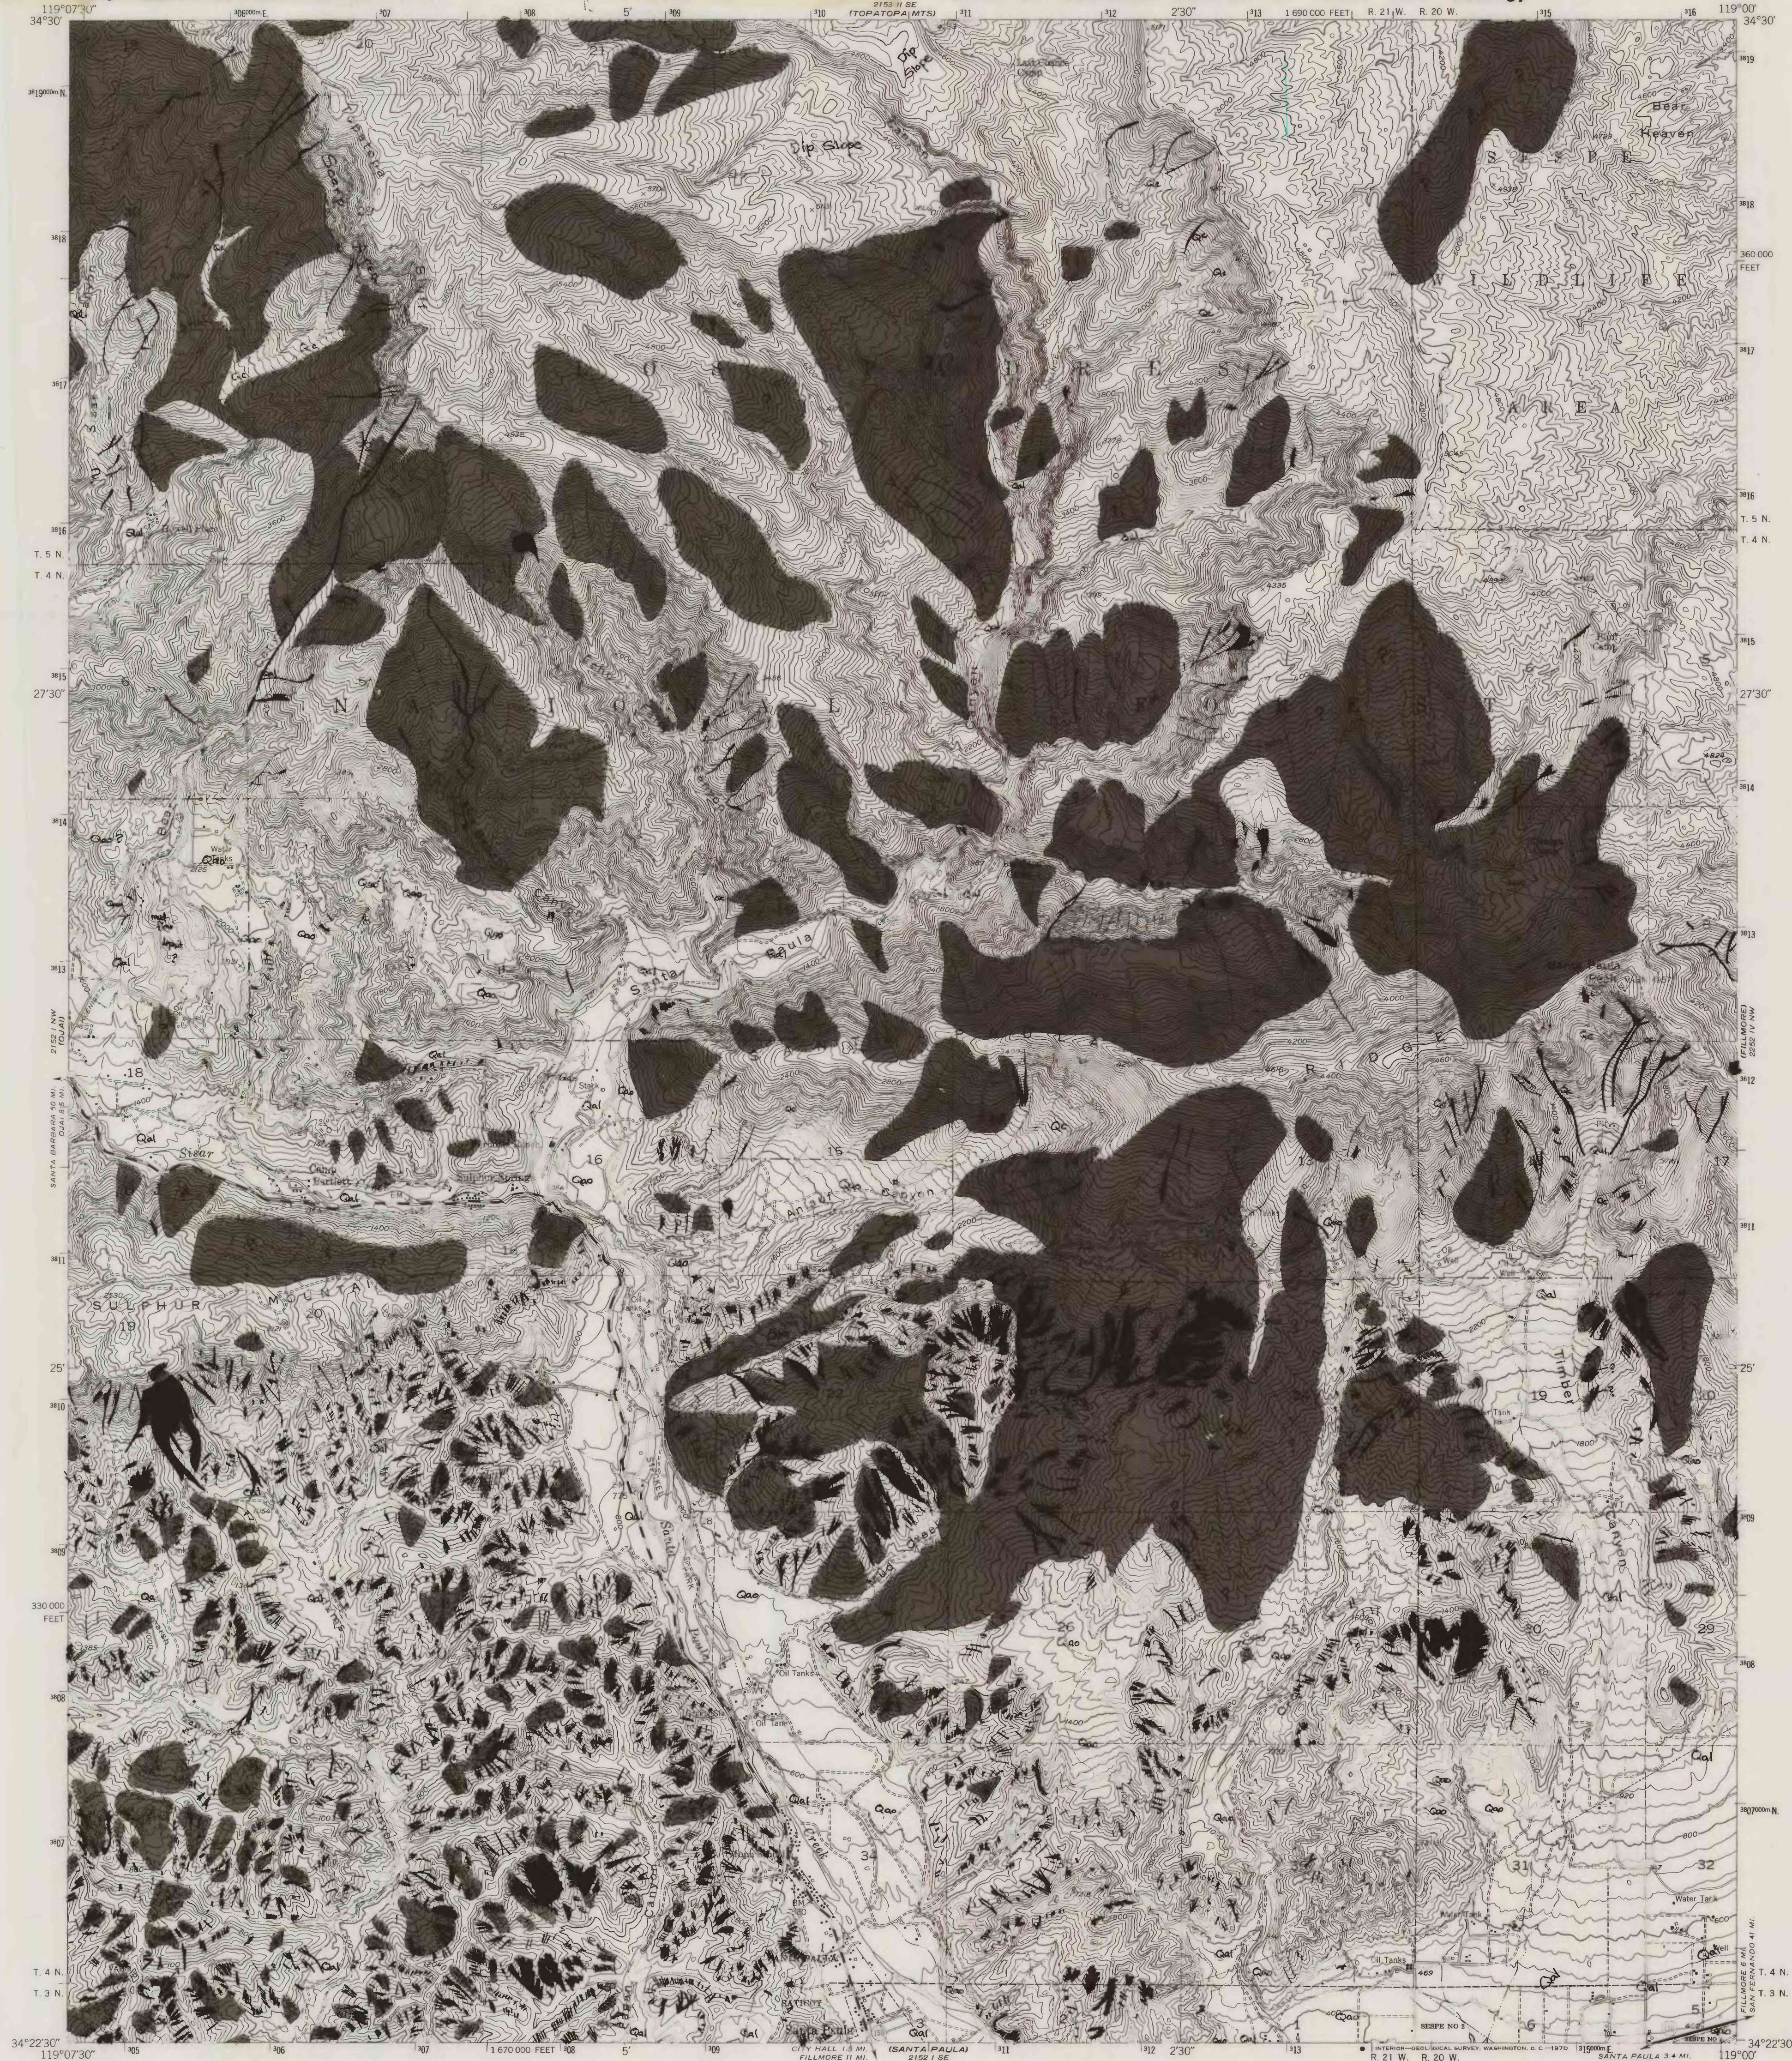
The accompanying map gives an inventory of the 1969 soil-slip scars and debris-flow channels and deposits in part of the Santa Clara River valley area. The map was prepared by interpretation of morphological features visible on high-quality black-and-white stereoscopic aerial photographs taken in August 1967 and July 1969 (scale 1:32,000). Only those features visible on the photographs were used in the determination of the nature and extent of the surficial units; only brief, widely scattered field checks were made.

The map does not distinguish between areas of soil-slip scars, routes of subsequent debris flows, or areas of debris-flow deposition—all are included together. Most of the distinguishable debris-flow scars and deposits were confined to first- through third-order stream basins (Strahler, 1952), although some of the distinguishable largest flows are in higher order basins. Most of the material transported by debris flows will eventually be transported onto major valley floors by fluvial flow.

Some large composite landslides, measured in square miles of areal extent, are difficult to recognize simply because they are so large. Such large landslides commonly contain obvious small satellite landslides that tend to attract attention away from the larger landslide. Landslides smaller than about 300 ft in maximum dimension were difficult to see on the photographs; those suspected of being landslides are marked by a query and are not bounded by contact lines. Areas with morphological features suggestive of but not definitely known to be landslides are queried. Some landslides too narrow to be shown accurately at the scale of this map are indicated by a single arrow. Within large landslides, internal satellite landslides and scarps are shown where they could be identified. Bedrock is not labeled.
